SERVICE BULLETIN #5

RF INTERFERENCE MODIFICATIONS

2 Channel Amplifiers

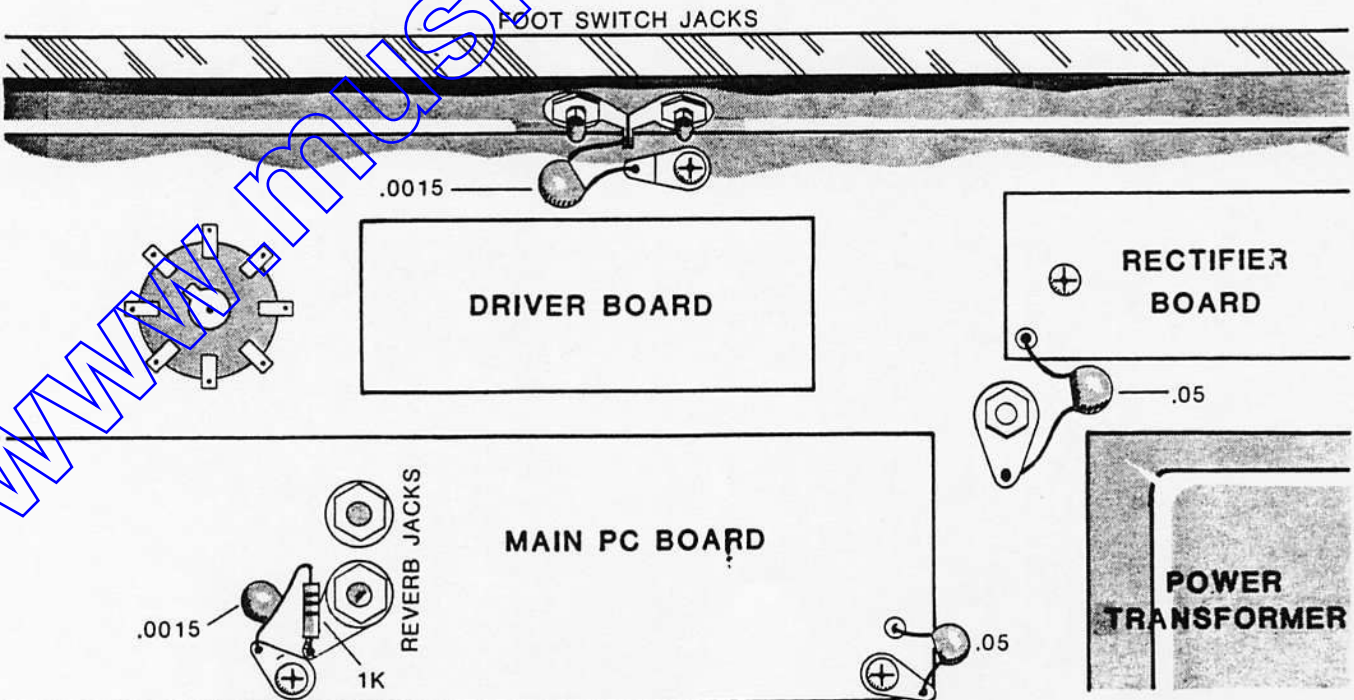
RF MODIFICATION DRAWING

1. (a) Install solder lug to chassis with output transformer mounting screw (located below footswitch jacks).
- (b) Solder .0015mf ceramic capacitor from solder lug to footswitch jack ground lug.
- (c) Install solder lug onto power transformer mounting bolt with extra kep nut.
- (d) Solder .05mf ceramic capacitor from solder lug to ground eyelet on rectifier board (corner eyelet).
2. (a) Install a solder lug on the main PC board under the bottom center board mounting screw.
- (b) Solder a .0015mf ceramic capacitor from the solder lug to the reverb spring jack ground. This can be done by soldering to the top lead of 1K resistor near the return jack.

1. Check for a .05mf ceramic capacitor installed from power supply ground (bottom right corner eyelet) to chassis ground (solder lug under corner PC board mounting screw). If it is missing, install one.
2. A very successful deterrent to RF is replacing the LM307H ICs with those of a bifet type such as the LF351H manufactured by National Semiconductor and others. These do not rectify RF. You may get by just replacing the input amplifiers, the reverb spring amplifier and the summing stage.
3. If the bifet ICs are unobtainable, a temporary solution would be to install 100pf capacitors from pin 2 to pin 3 of various ICs. This is a partial deterrent to RF especially when applied to the input amplifiers. A .001mf ceramic can be installed on the reverb return spring amplifier (pins 2 and 3).

4. Installation of .1mf ceramic capacitors from supply lines to ground will help eliminate RF and voltage spikes from appearing on the supply lines.

1. (a) Install a solder lug on the main circuit board under the center board mounting screw.
(b) Solder a .0015mf capacitor from this lug to circuit board ground (trace surrounding RCA phono jacks).
2. A very successful deterrent to RF is to replace some of the LM1458N ICs with a bifet type. These do not rectify RF. A suggested replacement is a National LF353N. RCA, Texas Instruments and others may have a similar bifet replacement that is applicable. Possible replacement areas are the input stage, the hi-gain stage and the reverb stages.
3. Texas Instruments Bi-Fet IC # TLO-72 is available from Music Man as a sub for LF-353N.
